USASC TECHNICAL REPORT

Analysis of FY 78 Army Aircraft Accidents

U.S. ARMY SAFETY CENTER

3W ANALYSIS OF FY 78 ARMY AIRCRAFT ACCIDENTS

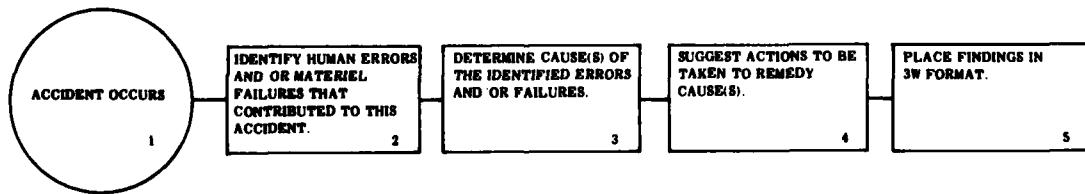
FIGURE 1.-Identification of Hazards in Each Individual Accident

As in prior years, the individual analysis of individual accidents to conform to 3W requirements was completed in accordance with the concepts and procedures outlined in chapter 11, AR 95-5, and as amplified in appendix F. These requirements were also discussed in the FY 77 3W report. Figure 1 shows the process used to analyze each accident.

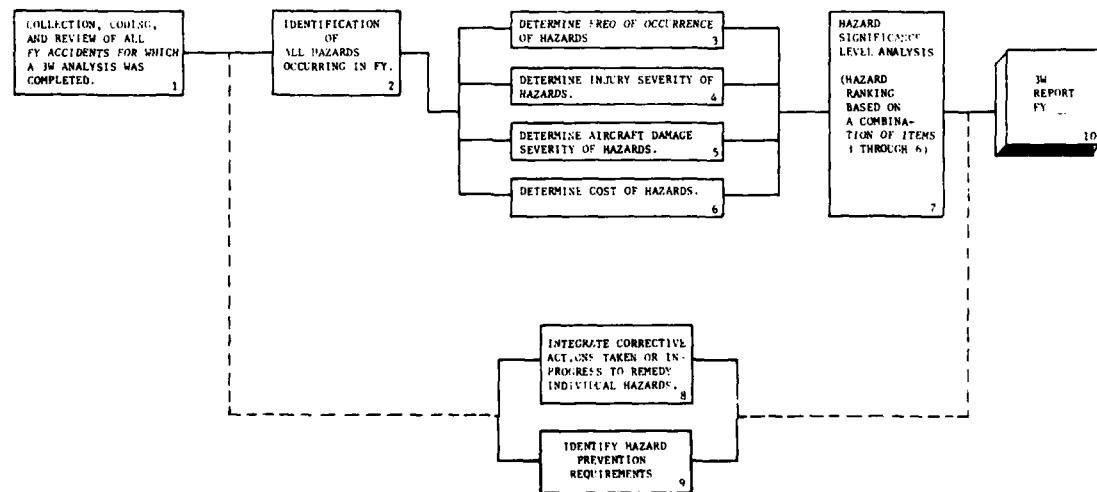
FIGURE 2.—Sequence of Overall Analysis

Collective Analysis. Figure 2 shows the process by which the collective analysis was accomplished.

All of the TEIR and FIRE data was collected, reviewed, and coded for the collective analysis (item 1). This process resulted in the identification of all system inadequacies or hazards that were reported in FY 78 (item 2). Appendix G provides a detailed 3W description of each hazard by accident case in booklet form.

Rank Ordering of Hazards. The next step was to identify in order of importance the most significant aviation hazards. To accomplish this task, a hazard significance level (HSL) analysis was performed (item 7). The result of the HSL analysis is a rank-ordering or totem pole of hazards according to their overall significance. The criteria for the significance ranking were based on a combination of four variables...the frequency of hazard occurrence (item 3), personnel injury (item 4), aircraft damage severity (item 5), and the dollar loss costs (item 6).

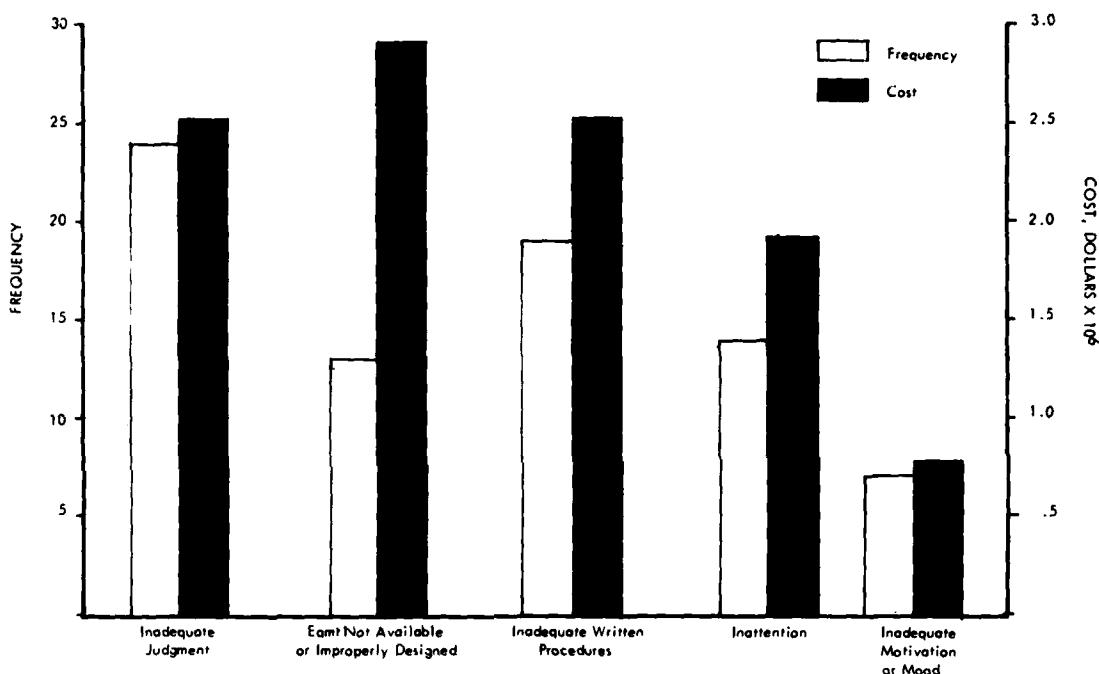
FIGURE 3.-Frequency and Cost of Top Five Hazards

A general discussion of the top five aviation hazards is presented in this section. More specific information can be obtained through a detailed examination of each case within a hazard category. Figure 3 shows the relationship of these hazards according to frequency and accident cost. Note that equipment design problems occurred less frequently than others but accounted for the greatest dollar losses.

Equipment design was the second ranked hazard. This category includes human as well as materiel failures caused by the inadequate design of equipment. Although equipment problems occurred in accidents less frequently than other hazards, it resulted in the highest dollar losses (see figure 3).

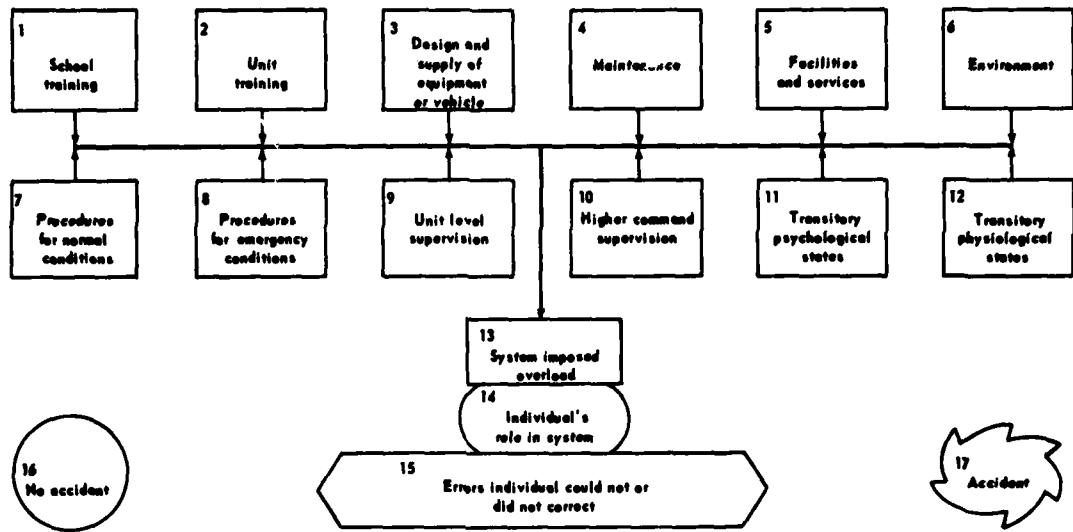
FIGURE 1.-Model of Human Error Accident

These 69 aircraft accidents were individually analyzed by accident investigation using the 3W approach. This approach is based on a conceptual framework adapted from a model by Ricketson, 1975. Figure 1 presents a model of the human-error accident. The premise of this model is that when one or more of the 12 basic elements of the aviation system do not operate as intended, an overload (item 13) is placed on the man's role in the system (item 14). That is, the man must continue to perform normal tasks while correcting for the abnormal system condition. If the overload is of such magnitude or persistence that the man cannot cope with it and continue to perform normal tasks, he begins to make errors (item 15). Most of these errors do not result in an accident (item 16). But, as the magnitude and frequency of errors increase, the likelihood of the error causing an accident increases. When an accident occurs that has been caused by a human error(s), it is probable that this error has occurred many times before the accident happened and is likely to continue to occur unless some remedial action is taken.

This basic model was used to develop the approach outlined in table 2. The approach requires the accident investigation board to identify what happened, what caused or allowed it to happen, and what to do about it (3W) with respect to man as a cause factor, the machine as a cause factor, and the environment as a cause factor. This report only addresses the man and machine cause factors.

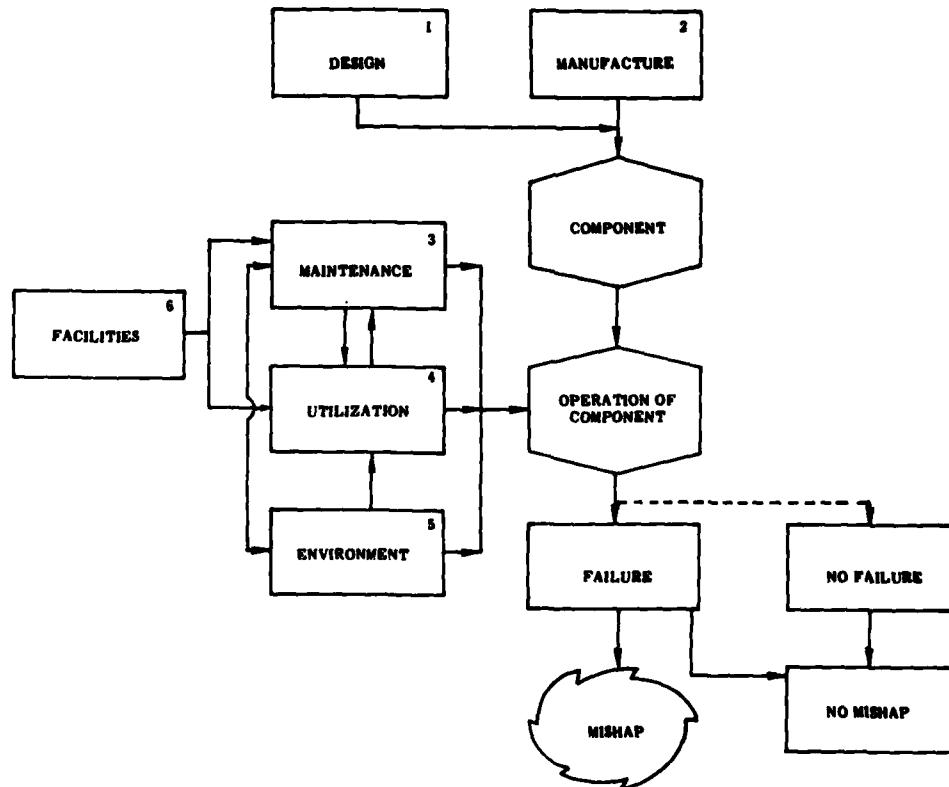
FIGURE 2.—3W Model of Mishap Caused by Materiel Failure/Malfunction

Materiel Failure. The 3W approach relating to materiel failure/malfunctions is also based on the conceptual framework adapted from Ricketson's (1975) model. Figure 2 presents a model of the materiel failure/malfunction accident.

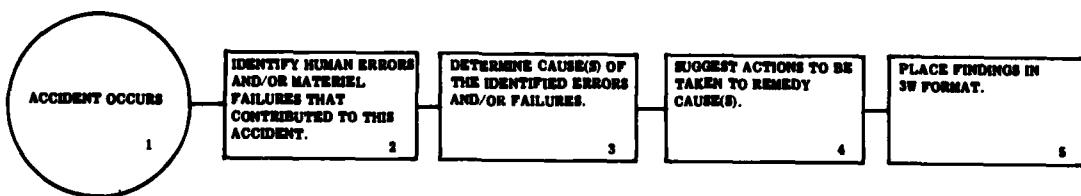
FIGURE 3.—Identification of Hazards in Each Individual Accident

Individual Accident Analysis. Figure 3 shows the general process by which the individual analysis of an accident was accomplished.

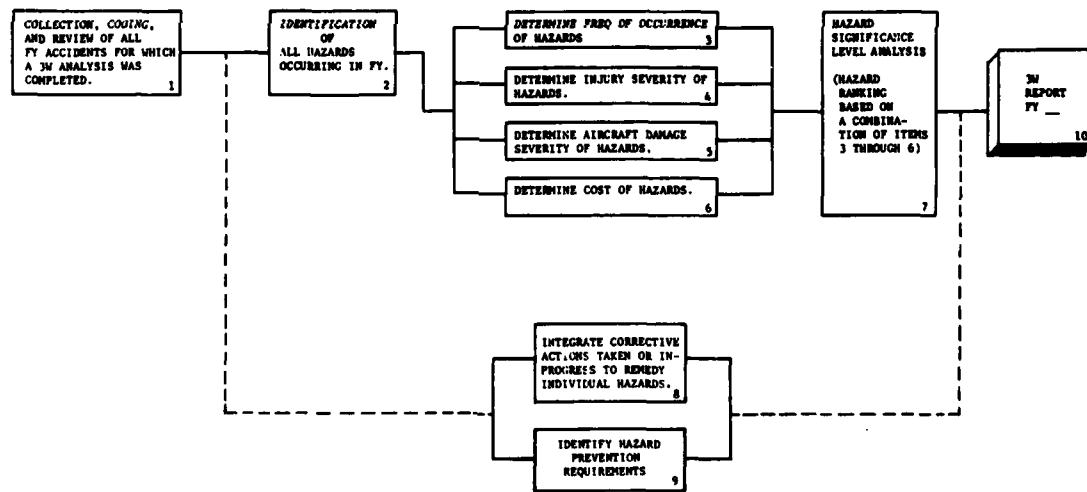
FIGURE 4.—Sequence of Overall Analysis

Collective Analysis. Figure 4 shows the process by which the overall analysis was accomplished.
